PENNSYLVANIA
NORTH FORK DAM

NDS ID NO. PA-28
DER ID NO. 53-57
SCS ID NO. PA-406

PHASE I INSPECTION REPORT
NATIONAL DAM INSPECTION PROGRAM

NAME OF DAM: North Fork Dam
STATE LOCATED: Pennsylvania
COUNTY LOCATED: Potter
STREAM: White Branch of North Fork
DATE OF INSPECTION: June 27, 1979

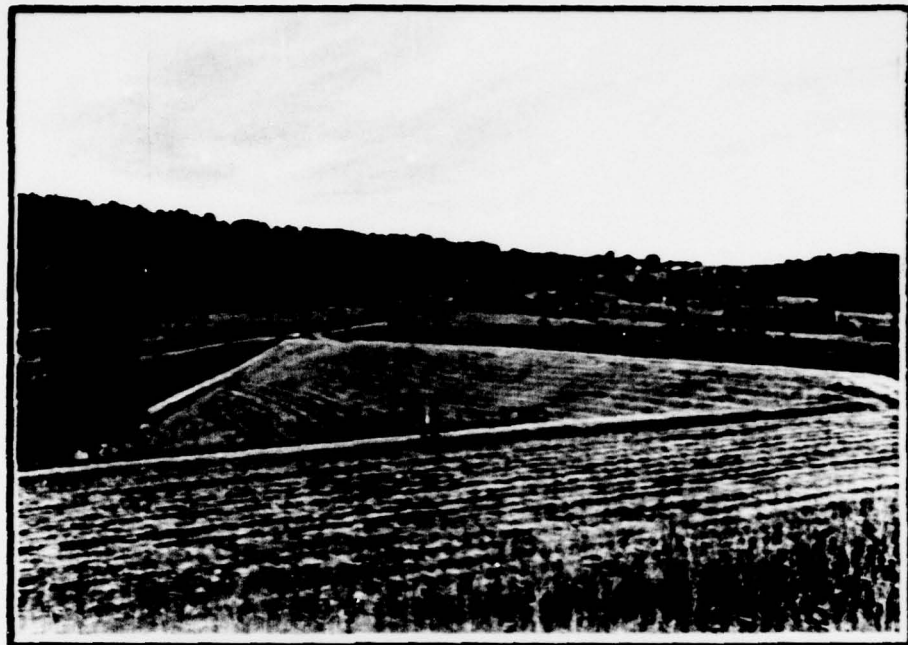
Overview of downstream slope of dam.

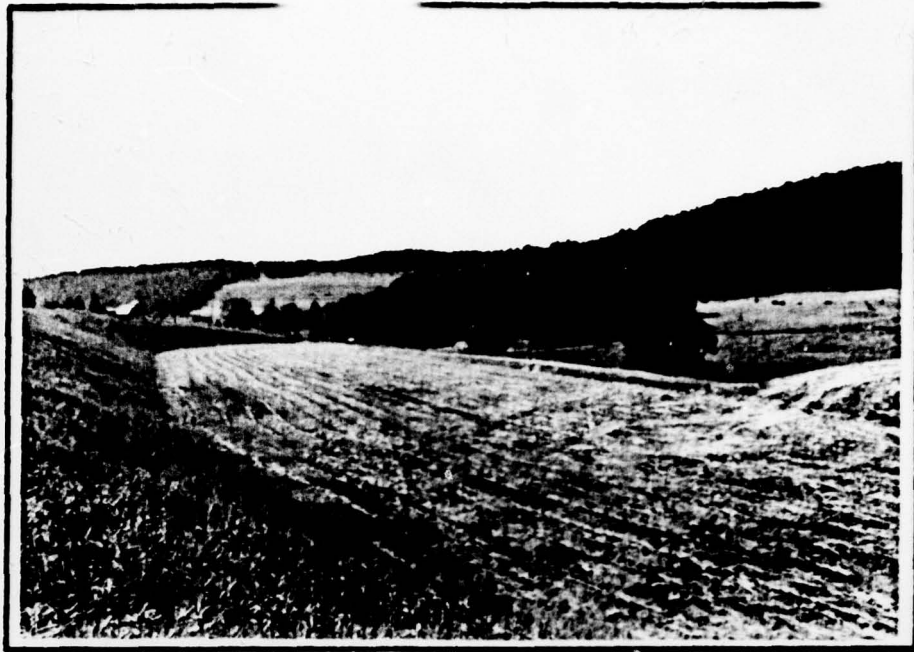
c. Visual Observation. Principal spillway and emergency spillway facilities appeared to be in good condition. However, the earth berm on the right portion of the emergency spillway discharge channel is approximately 5 feet lower than the top of dam. During flooding conditions, flow over this berm will cause erosion of the embankment abutment contact.

The spillway and reservoir are capable of controlling approximately 60% of the PMF without overtopping the embankment. However, because of the low earth berm on the spillway exit channel, flow over the berm will cause erosion of the embankment/abutment contact. The earth berm will overtop with approximately 25% of the PMF.

VISUAL EXAMINATION OF	OBSERVATIONS	REMARKS OR RECOMMENDATIONS
CONCRETE WEIR	No concrete weir. Grassed control section - good condition.	
APPROACH CHANNEL	Open cut in good condition.	
DISCHARGE CHANNEL	Open cut in good condition - except for seepage exiting left cut slope and minor movement of slope. Right berm on exit channel approx. 5 feet lower than top of dam. Flow over this berm during flooding will erode embankment abutment.	
BRIDGE AND PIERS	None.

Emergency spillway discharge channel.
Note low spot on right berm.

1. Raise the earth berm on the right spillway discharge channel to the top of dam elevation.
2. The wet area at the bottom of the right rock gutter should be regraded to provide positive drainage.
3. The wet area on the left cut slope of the emergency spillway should be watched closely for movement and drainage provided.
4. A warning system should be instituted to warn downstream residents of large spillway discharges or failure of the dam.
5. A safety inspection should be conducted by a registered professional engineer knowledgeable in dam design in accordance with Commonwealth of Pennsylvania regulations.

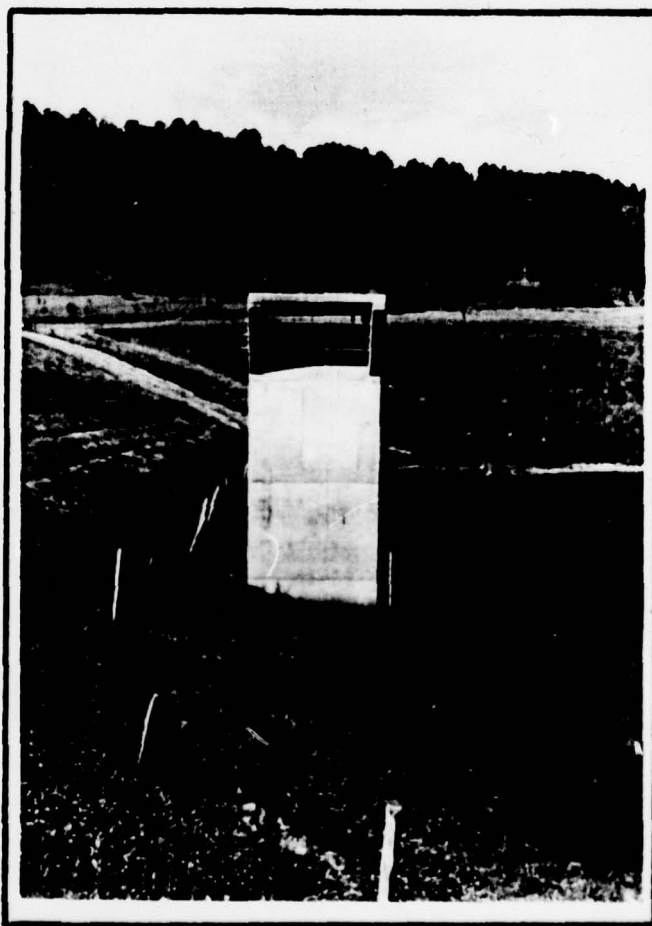
Principal spillway.

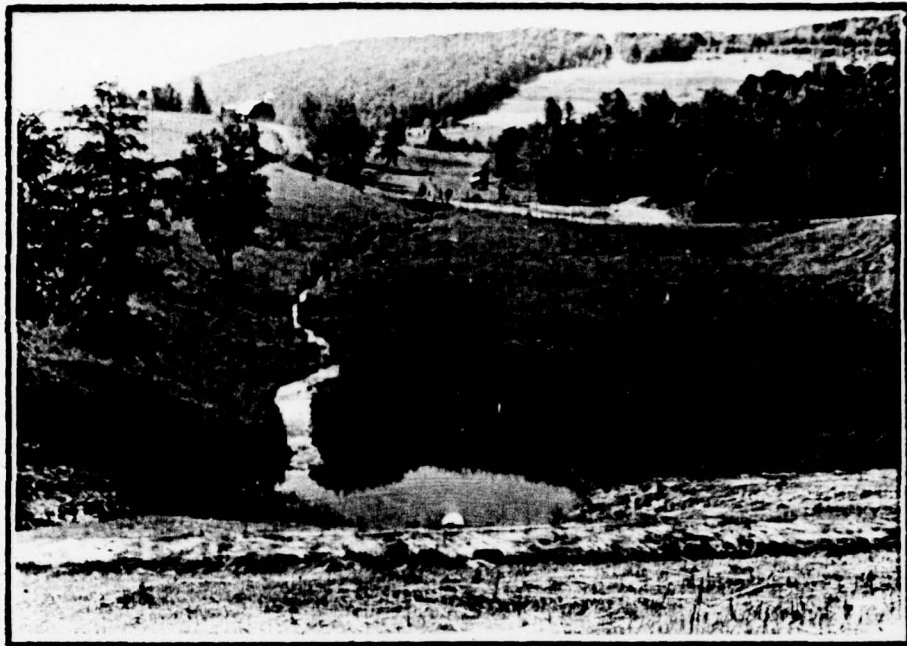
Immediate downstream channel.

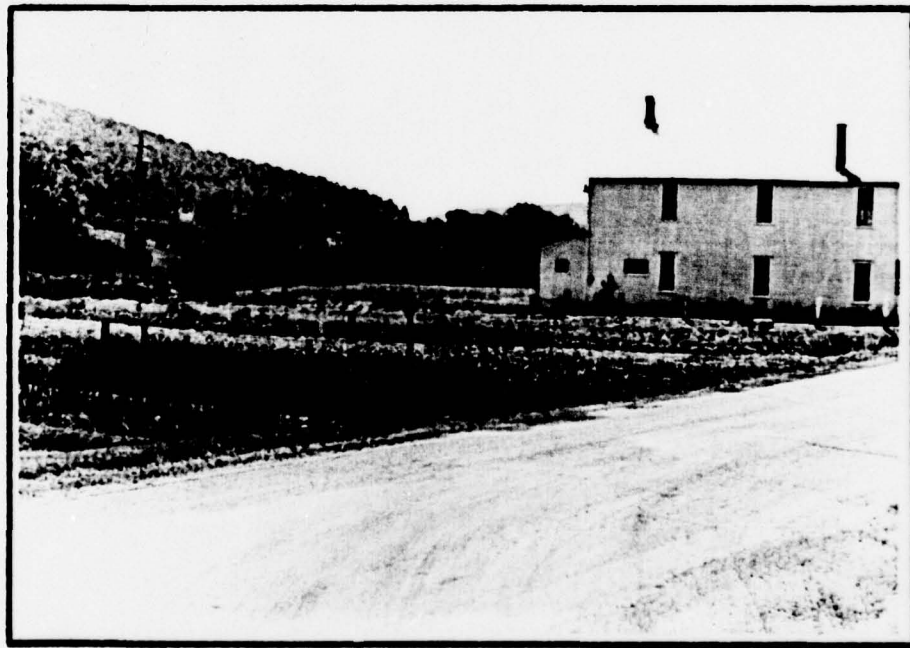
Residence in village of North Fork.
